October 28, 2024

Re: Pool Building Complex
5th Avenue South
Clinton, Iowa 52732
IMEG Project #23003451.00

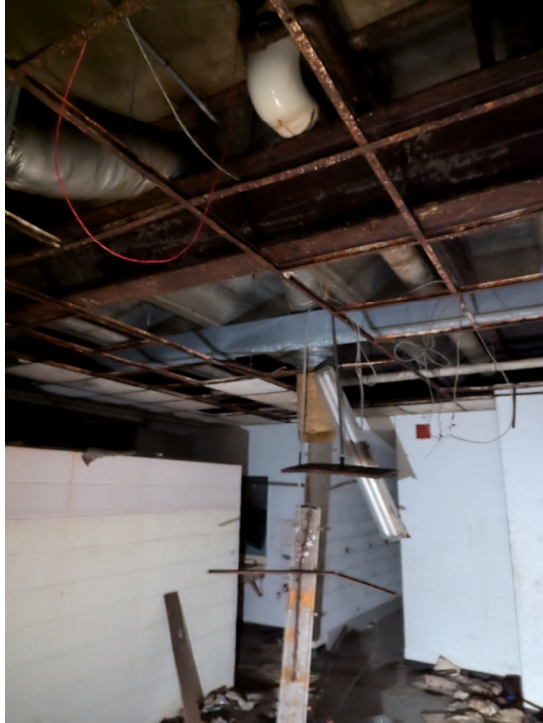
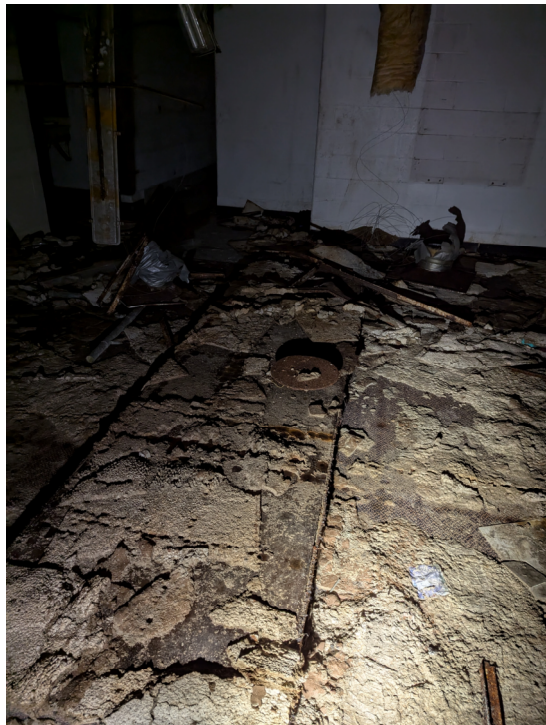
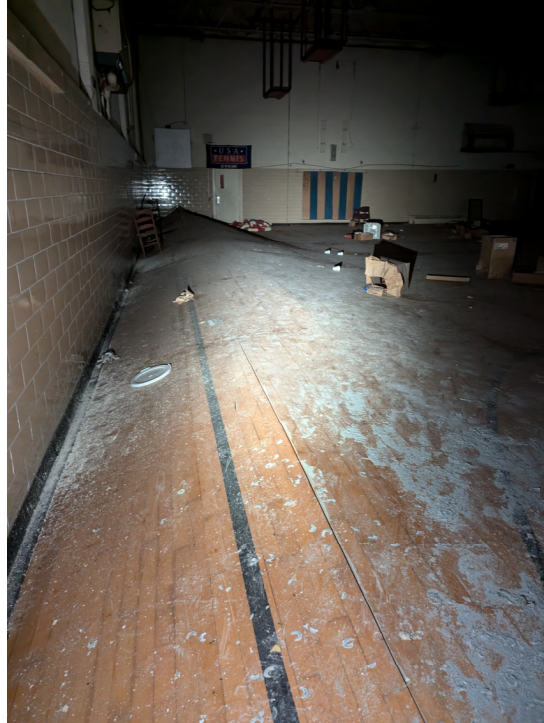
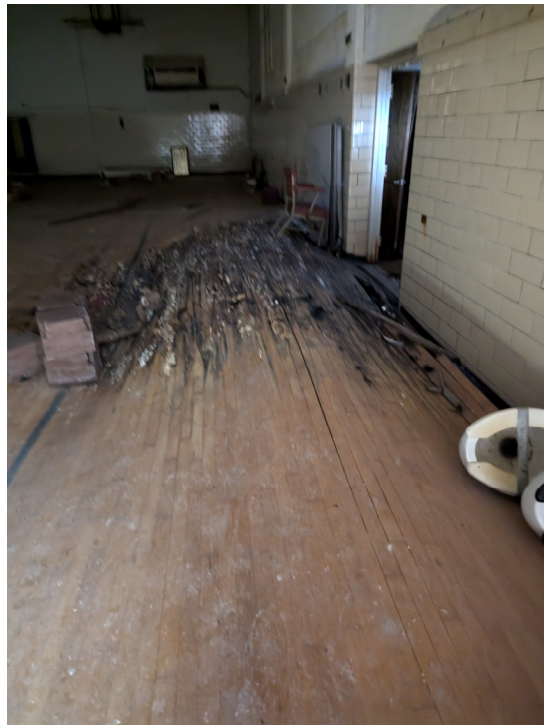
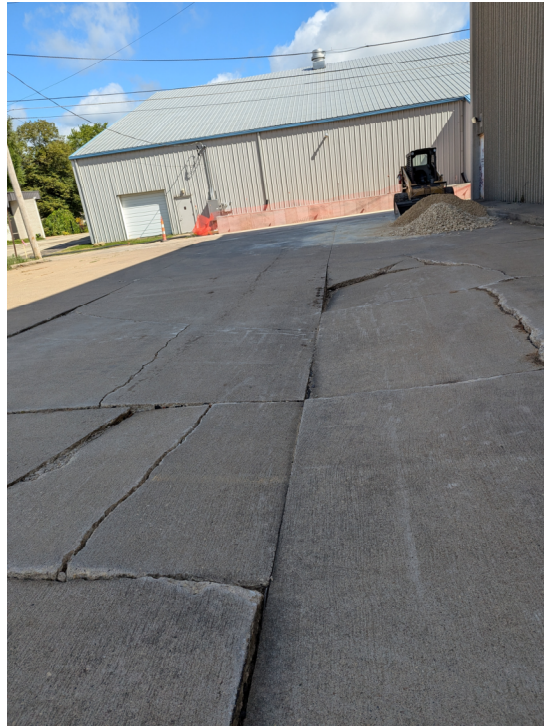
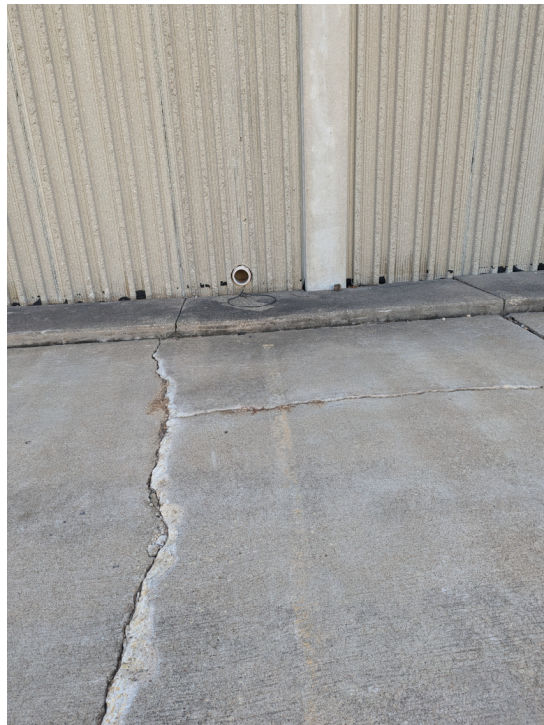
It is our opinion based on our site observations that the addition to the pool building / basketball court / locker room building west of the original building is an unsafe structure in accordance with International Building Code Section 116.1.

We noticed the basketball floor had buckled and warped which may lead to destabilizing the walls, mold/mildew and mushrooms growing on the floor inside the building, rusted steel beam framing and ceiling panels collapsed all due to leaking roof structure over the years.

Also, we noted the pavement adjacent to the complex to be heavily cracked. In addition, the pavement appeared to have settled or undermined perhaps due to downspout discharging improperly under the pavement.

Our recommendation is that this building be removed in accordance with IBC. In addition, it is our understanding that the building contains asbestos and should be demolished in accordance with RACAM requirements.
